GUIDEBOOK NO. 14

GEOLOGY ALONG THE TOWPATH: STONES OF THE OHIO & ERIE AND MIAMI & ERIE CANALS

Joseph T. Hannibal
The Cleveland Museum of Natural History

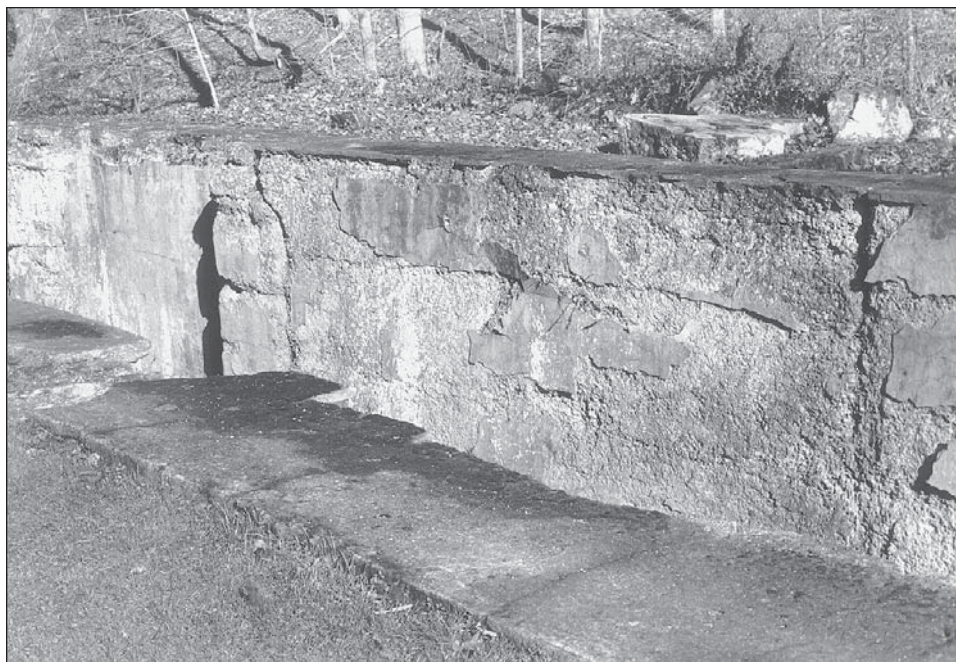
FIGURE 12.—Lock 30 of the Ohio & Erie Canal, Cuyahoga Valley National Recreation Area. This lock is composed mostly of concrete, which is exfoliating. Discarded stone from the original structure can be seen beyond the lock. November 1997 photo.

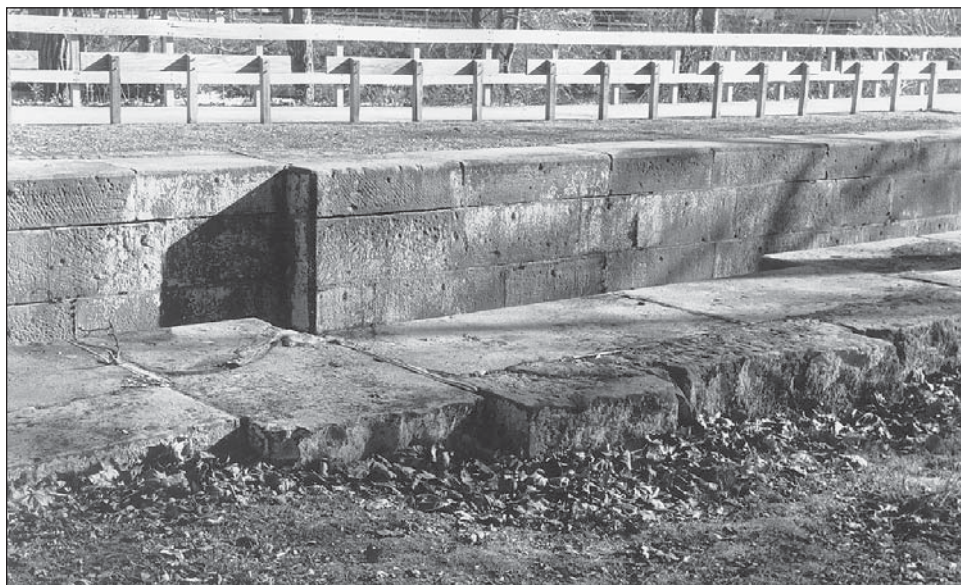
FIGURE 15.—Top portion of Lock 29. Note the angular quoins of the lock recess and the rough, unfinished outer edges of the stone across the center of the photo. November 1997 photo.

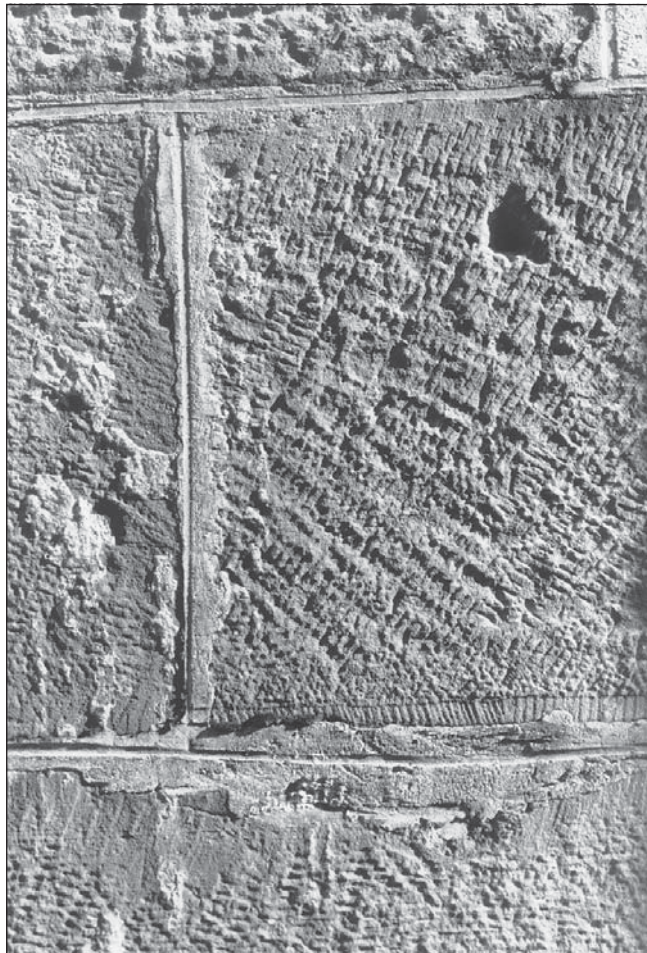
FIGURE 17.—Stone of Lock 29 showing roughly bush hammered interior, drafted margins, and cement mortar. November 1997 photo.

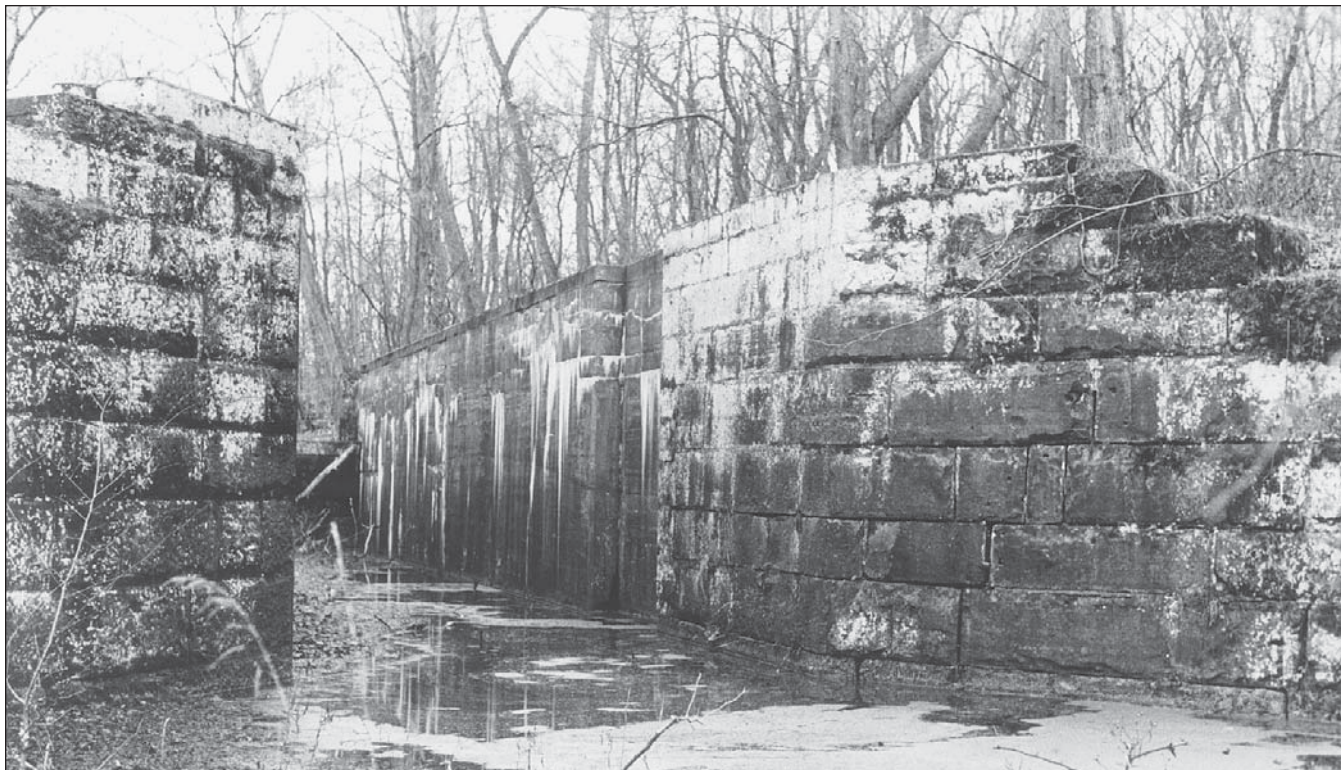
FIGURE 20.—Deep Lock (Lock 28), Cuyahoga Valley National Recreation Area. The lower level (front end) of the lock (foreground) is sandstone block. The back portion of the lock is concrete. The iciclelike streaks on the concrete are encrustations of salts that have dissolved from the concrete. December 1997 photo.

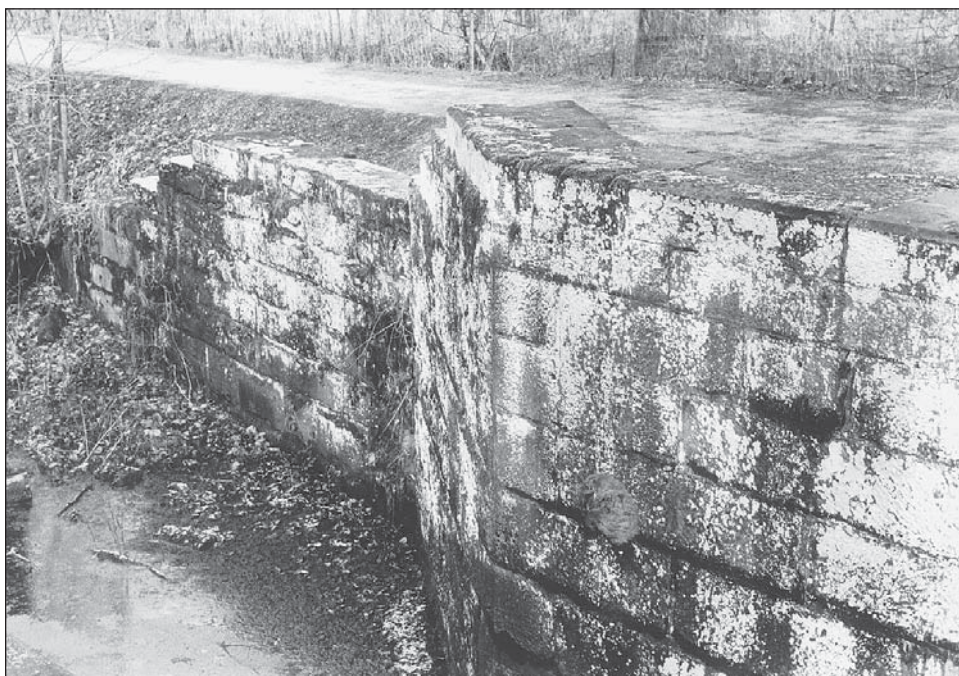
FIGURE 21. —Lower level end of Deep Lock, which is heavily encrusted by lichen and moss. Note towpath trail at top of photo. December 1997 photo.

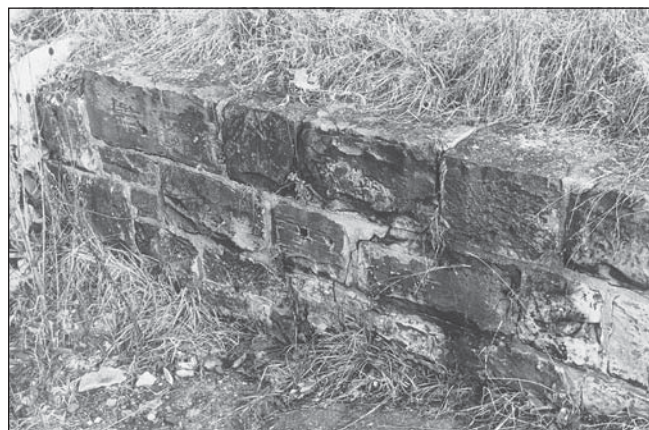
FIGURE 23.—Spillway, constructed of conglomeratic sandstone, probably the Sharon conglomerate, adjacent to Lock 14, Cascade Mills Lock, part of Cascade Valley Metropark. December 1997 photo.

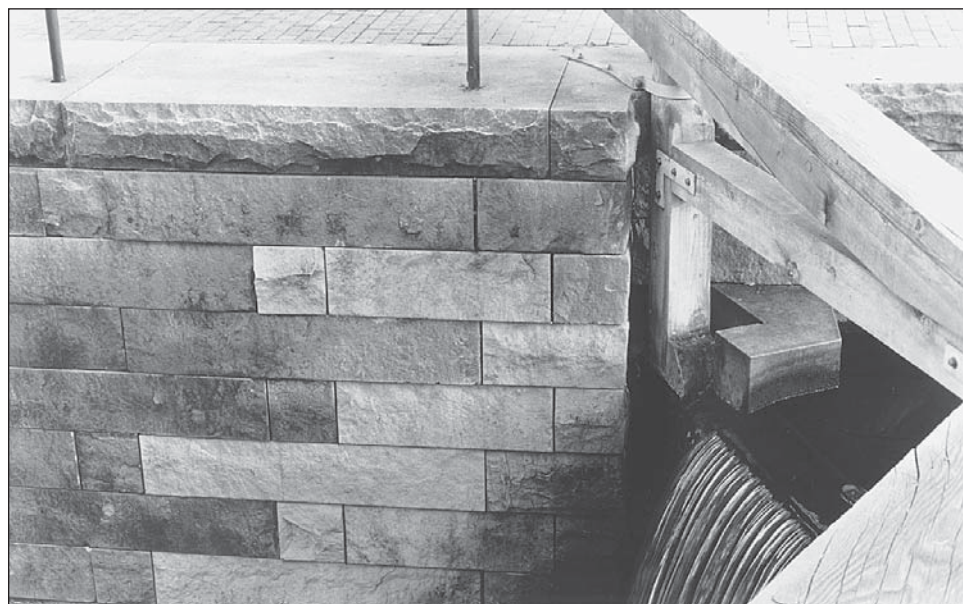
FIGURE 26.—Close-up view of stone used for reconstructed Lock II. Note that the finish of the stone does not attempt to replicate that of the original canal structures. It is split faced instead of bush hammered, as were most original canal stones. This difference in finish helps to identify the lock as a replica. December 1997 photo.

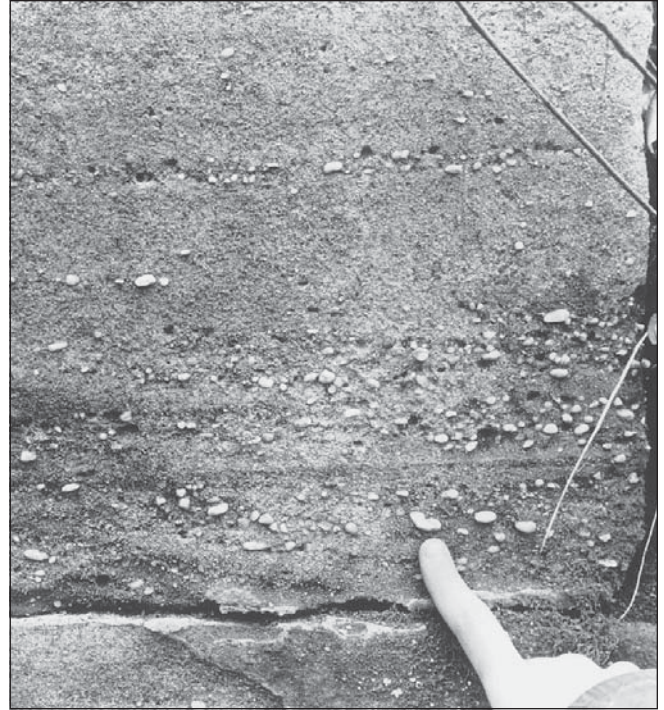
FIGURE 31.—Block of Black Hand Sandstone Member of the Cuyahoga Formation used for outlet lock at Black Hand Gorge. Note abundant quartz pebbles. January 1998 photo.

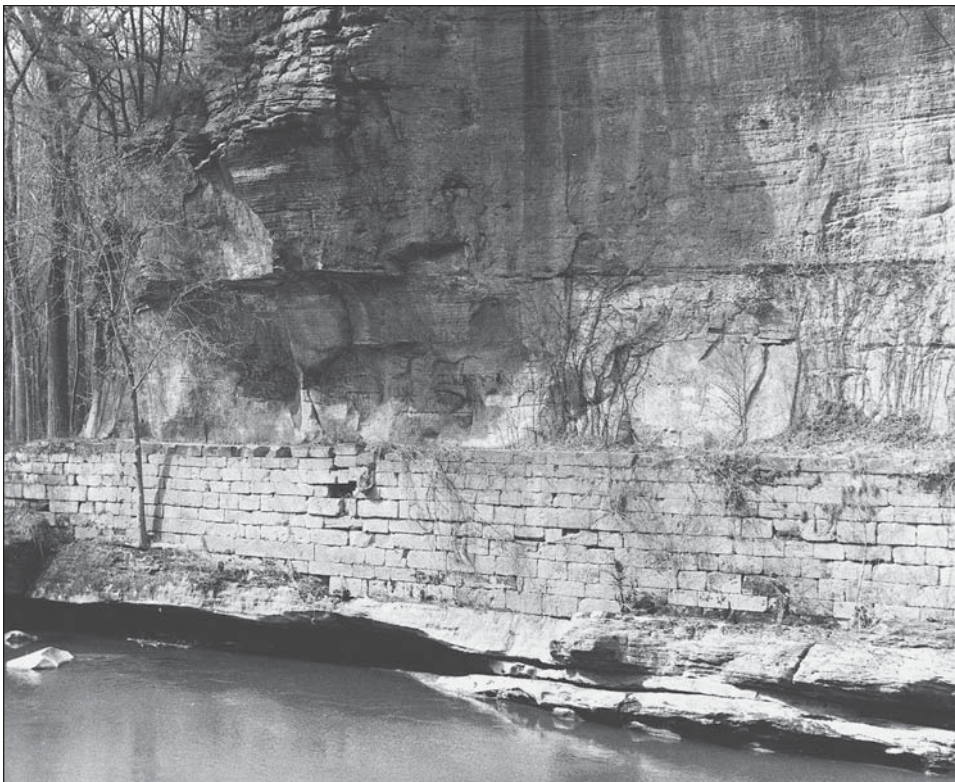
FIGURE 32.—Built-up towpath at Black Hand Gorge and towering remains of Black Hand Rock above. Visible portion of towpath is composed of courses of sandstone blocks. During canal days, the water level here would have been higher, covering the lower courses of stone. March 1998 photo.

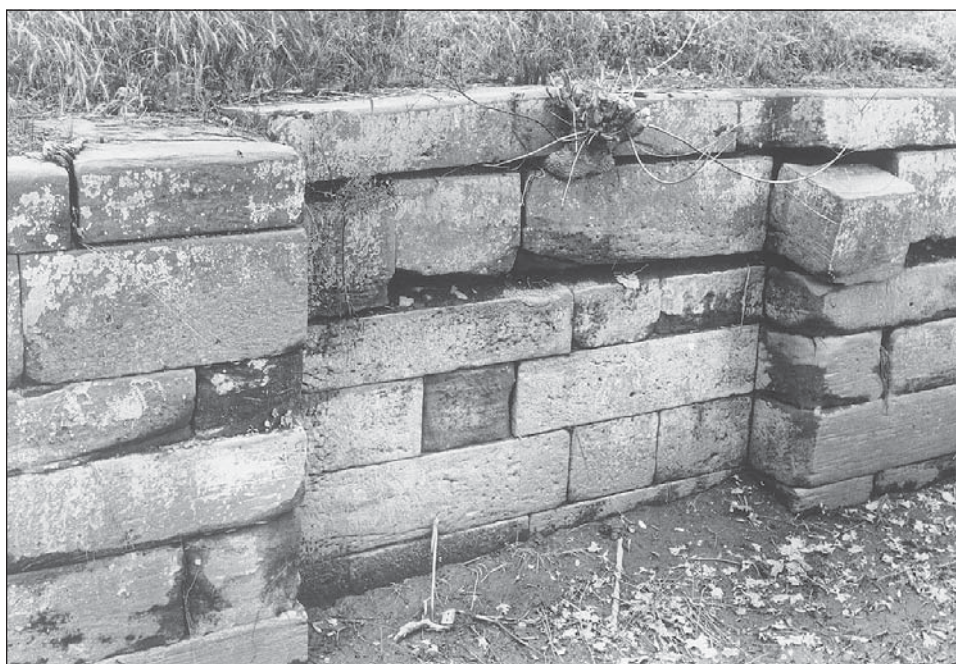
FIGURE 36.—Gate recess of Lock 30, Lockbourne. June 1997 photo.

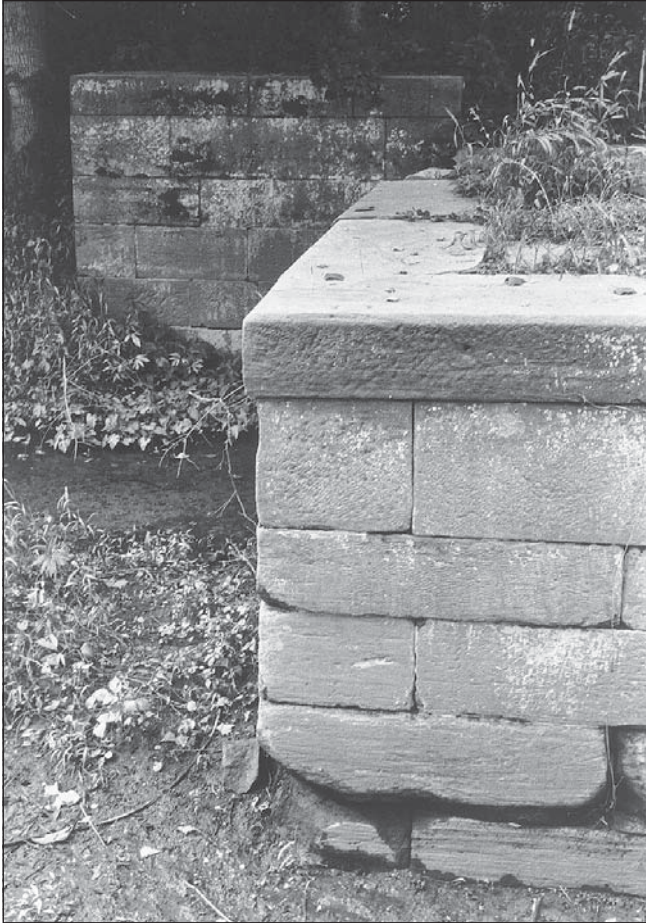
FIGURE 37.—Lock 30, Lockbourne, showing angular corners typical of Ohio & Erie Canal locks. Upper courses show original dressed faces. Lower courses have been weathered, exposing natural bedding of the stone. In the background is an unusual wall that extends from the spillway. June 1997 photo.

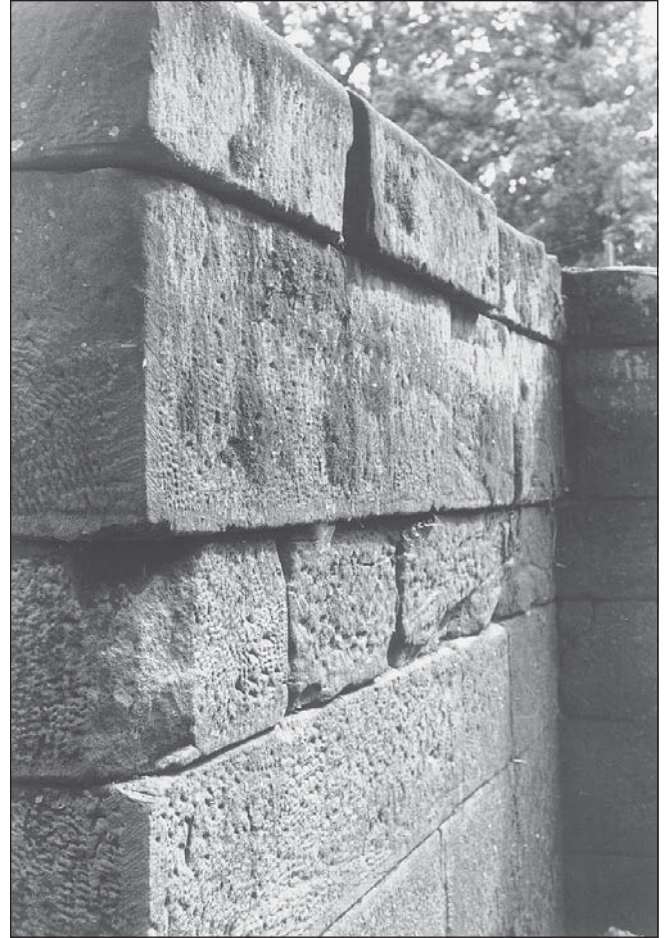
FIGURE 38.—Close-up view of the higher, east end of Lock 30, Lockbourne, showing state of stone blocks, weathered areas, drafted margins, etc. June 1997 photo.

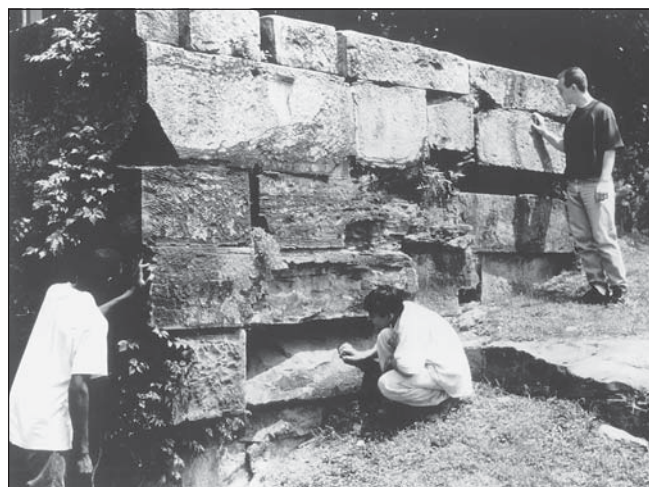
FIGURE 43.—Structure associated with Lock 44, Canal Park, Waverly. Several blocks have severely deteriorated. June 1995 photo.

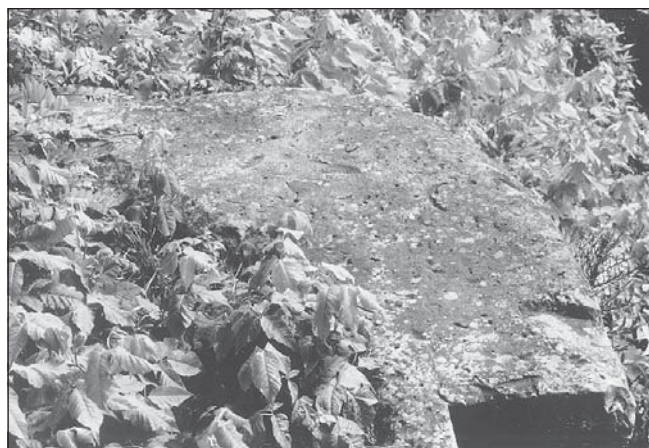
FIGURE 45.—Coping of West Portsmouth lock, made of sandstone from the Buena Vista Member of the Cuyahoga Formation. Lock is west of Ohio Rtes. 73/104 and north of turn-off to Ohio Rte. 239. Note rounded edge of lock and poison ivy. June 1995 photo.

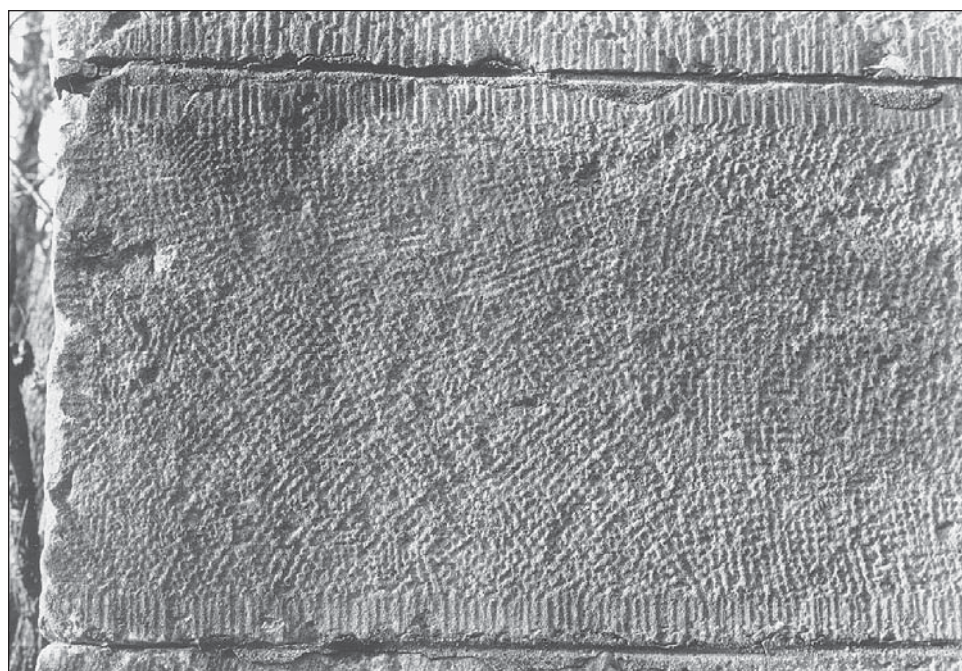
FIGURE 51.—Finely tooled stone block of Lock 4, Side Cut Metropark, Maumee. Note drafted margins and bush-hammered interior. December 1997 photo.

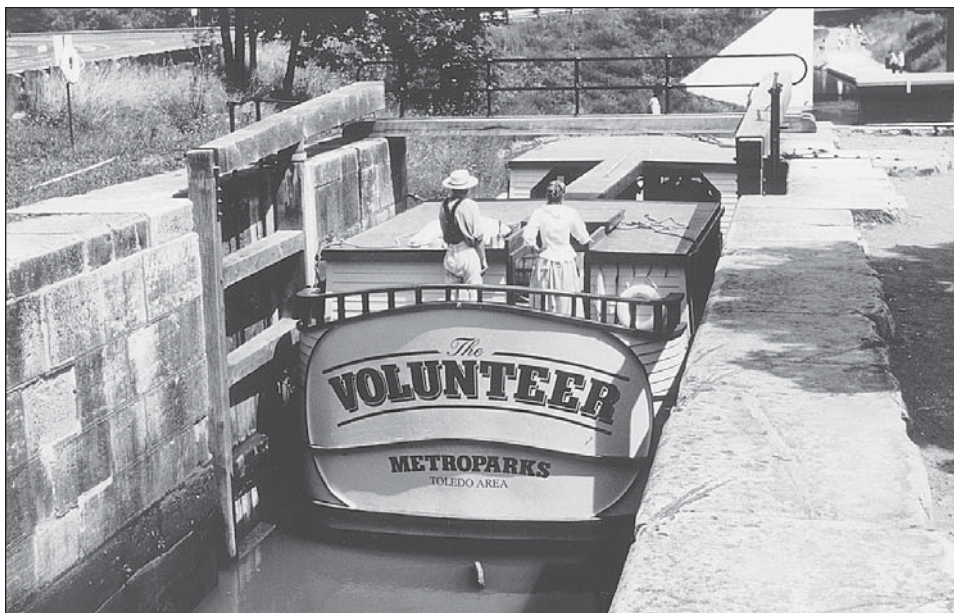
FIGURE 55.—*The Volunteer* clearing the lower gates of Lock 44 at Providence Metropark. The boat is being pulled by mules (just out of view on towpath to right). Note how the gates fit into the gate recesses. Also note rope grooves in coping in right foreground. August 1995 photo.

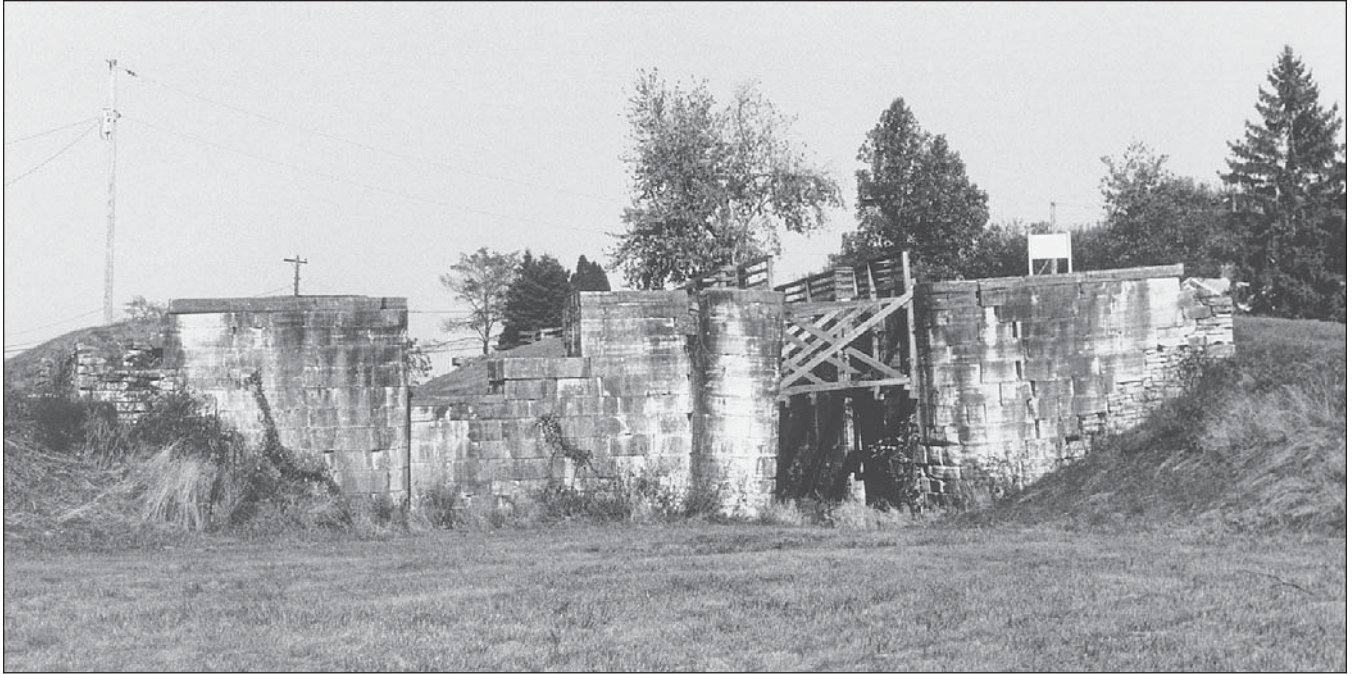
FIGURE 57.—Lower side of Lock 1, Big Lock, at Lockington. The tumble of the spillway is the two-level opening to the left; the lock chamber is to the right. October 1997 photo.

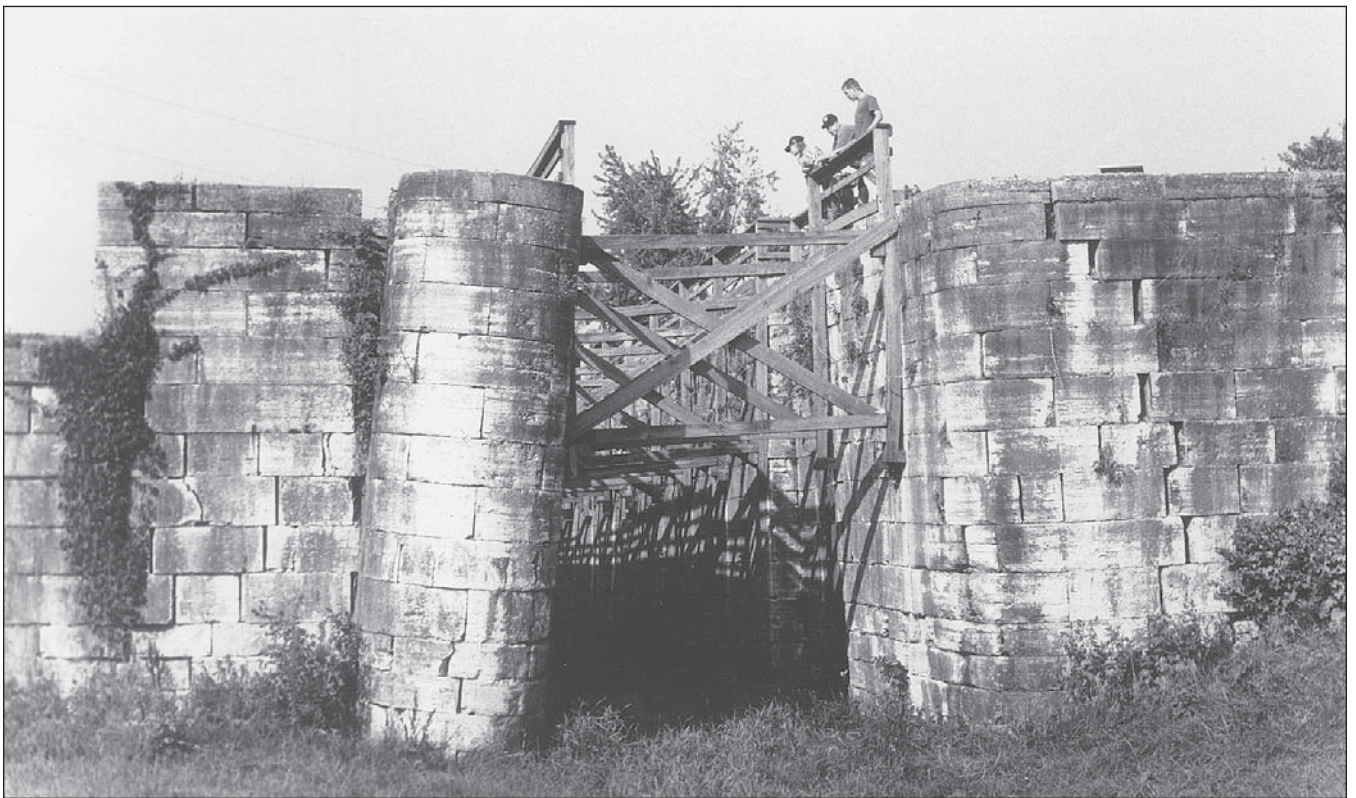
FIGURE 58.—Closer view of lower side of Lock 1, Big Lock, at Lockington. This lock is topographically high and is affected by a storm sewer just uphill. Note the inward tilt of the lock walls, the wooden structure holding the walls apart, and the separation of some of the blocks to the right. The edge of the spillway is to the left. August 1994 photograph.

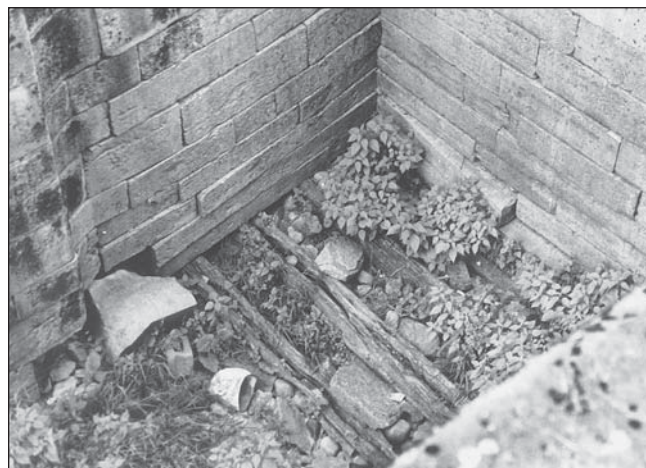
FIGURE 61.—Decaying wood at base of Lock 3, Lockington. Note slipping blocks of stone. August 1994 photo.

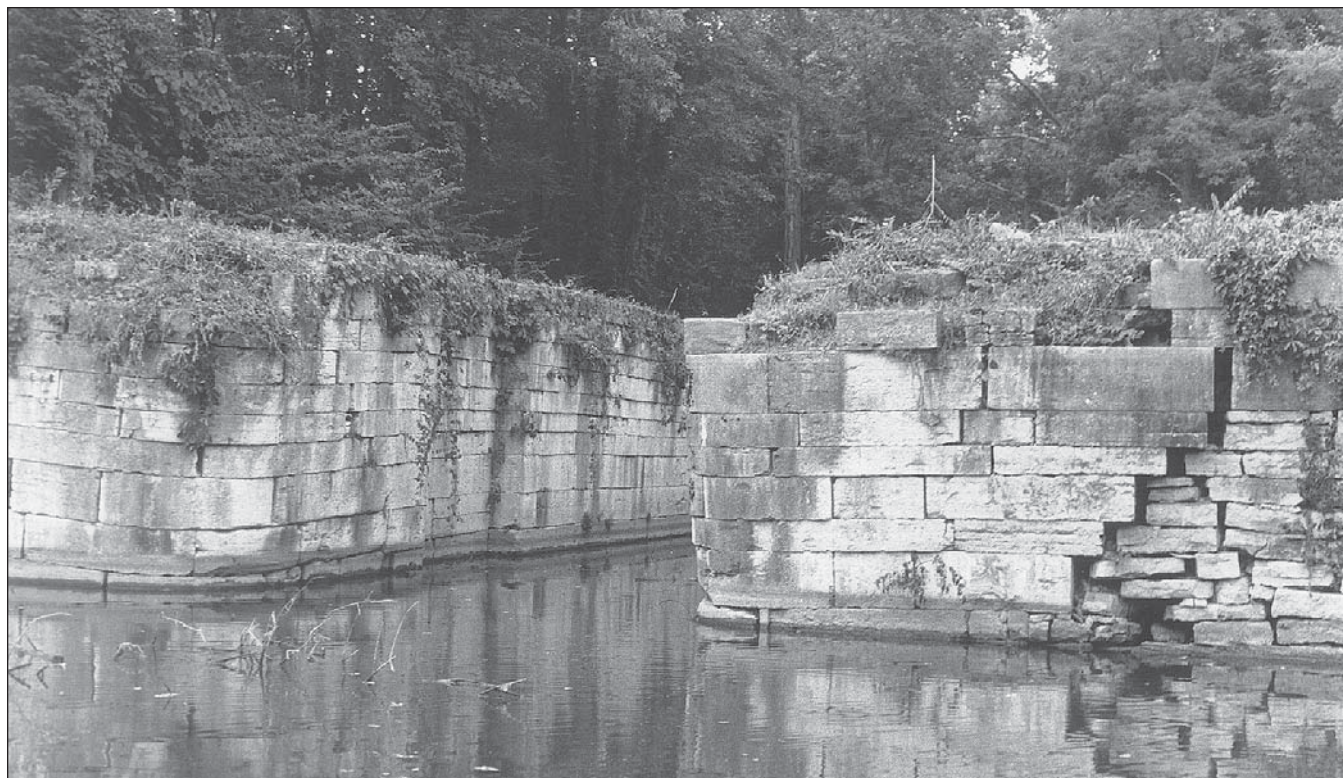
FIGURE 64.—Lock 8, Piqua Historical Area. Note greater deterioration of stone at water level and the leaning of the locks inward. Photo taken from the *Genl. Harrison* at a turn-around of the canal boat ride. August 1994 photo.

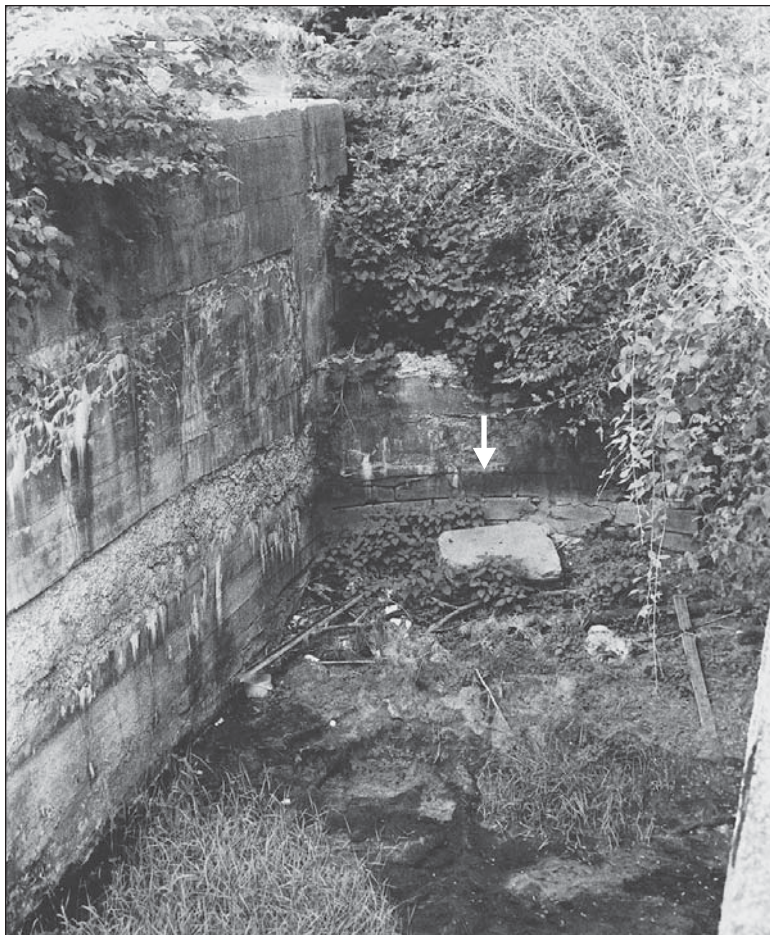
FIGURE 71.—Detail of upper end of Lock 34, Excello. Arrow points to a few courses of original stone. Remainder of the lock is concrete. August 1998 photo.

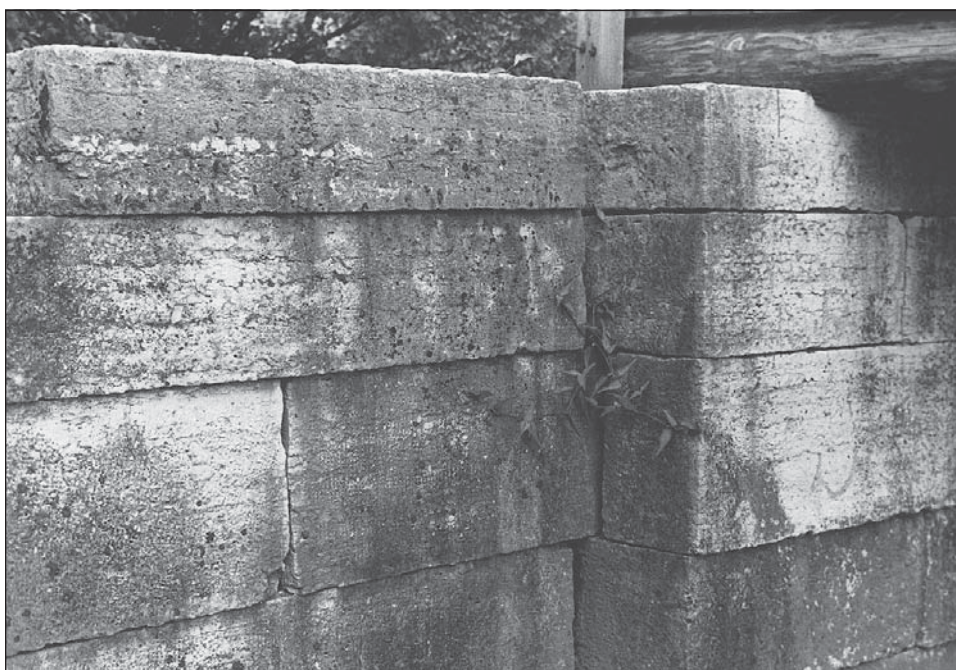
FIGURE 74.—Spillway at Lock 34, Excello, constructed of *Dayton limestone*. August 1998 photo.

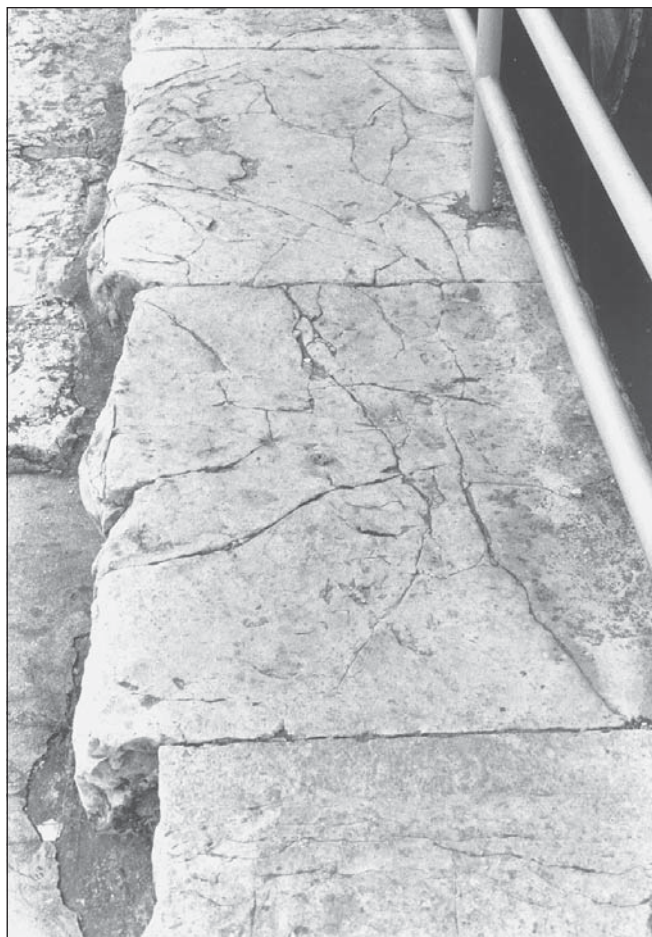
FIGURE 77.—Cracking in limestone used for coping of middle of south wall of Lock 25 at Metamora, Indiana. Pattern of cracks is typical of many limestones. August 1995 photo.
